TECHNICAL REPORT
R-54

FACTORS THAT AFFECT OPERATIONAL RELIABILITY OF TURBOJET ENGINES

By LEWIS CENTER STAFF

1960

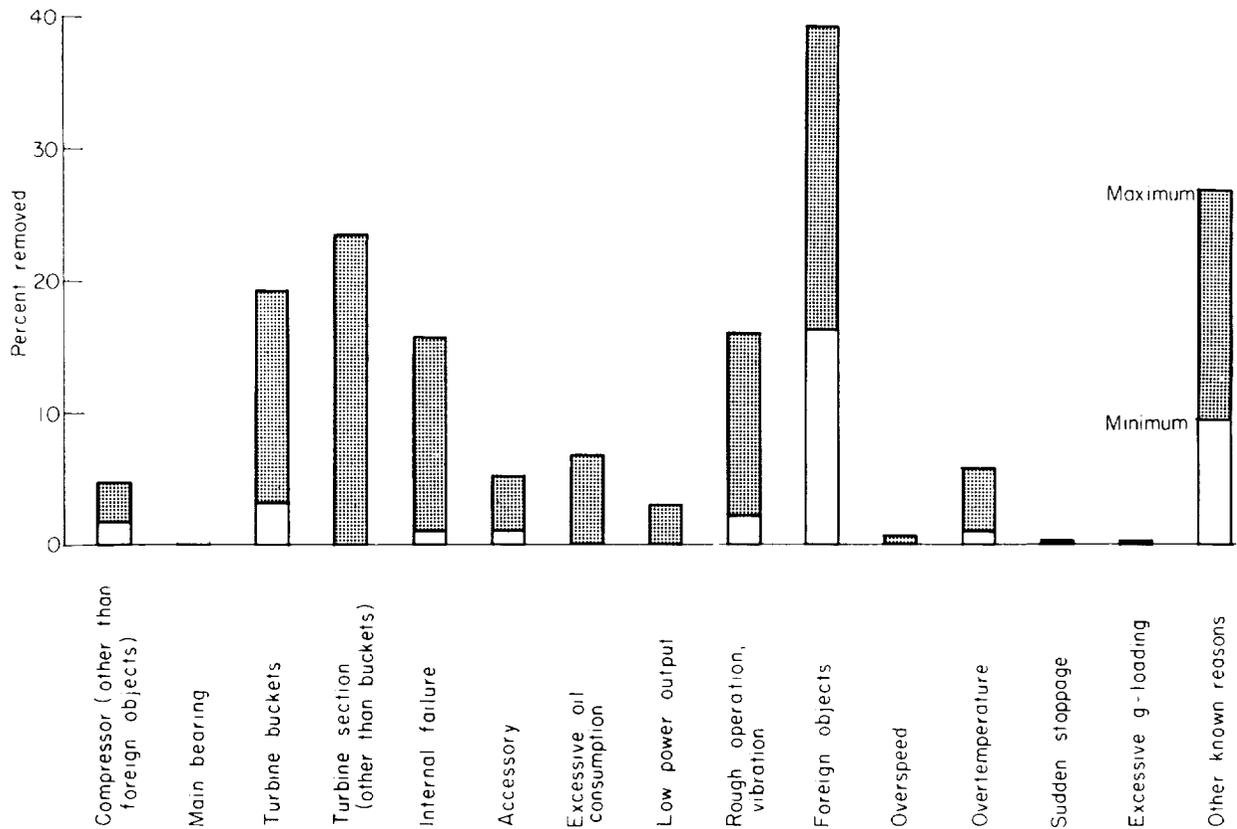
FIGURE 5. Causes for engine removal for five engine models (from ER's).

The distribution of reasons for removal among the five individual engine models is shown in figure 6. One of the largest categories for every engine model is the number removed for other known reasons not specified by code, which varied between 9 and 27 percent (fig. 5). The bearing category rarely shows any entries. If a main bearing were bad, it might be more likely noted under rough operation or excessive vibration, since the engine had not been disassembled to a point where those making out the engine removal form could see the damaged bearing. The cause of the rough operation or vibration

would not be known until the engine could be disassembled in field repair or in overhaul. The importance of a particular component in causing engine removals varies from engine to engine. For example, the turbine section other than buckets caused 23 percent of the removals in one engine, but none in another. This is indicated by the fact that the shaded area goes down to the axis (fig. 5).

Another point is that foreign-object damage is consistently a problem. At a minimum, it caused 9 percent of the removals of one engine model and up to a maximum of 39 percent of another

model. Other causes that were high were turbine buckets, internal failure, engine accessories, and rough operation or vibration.

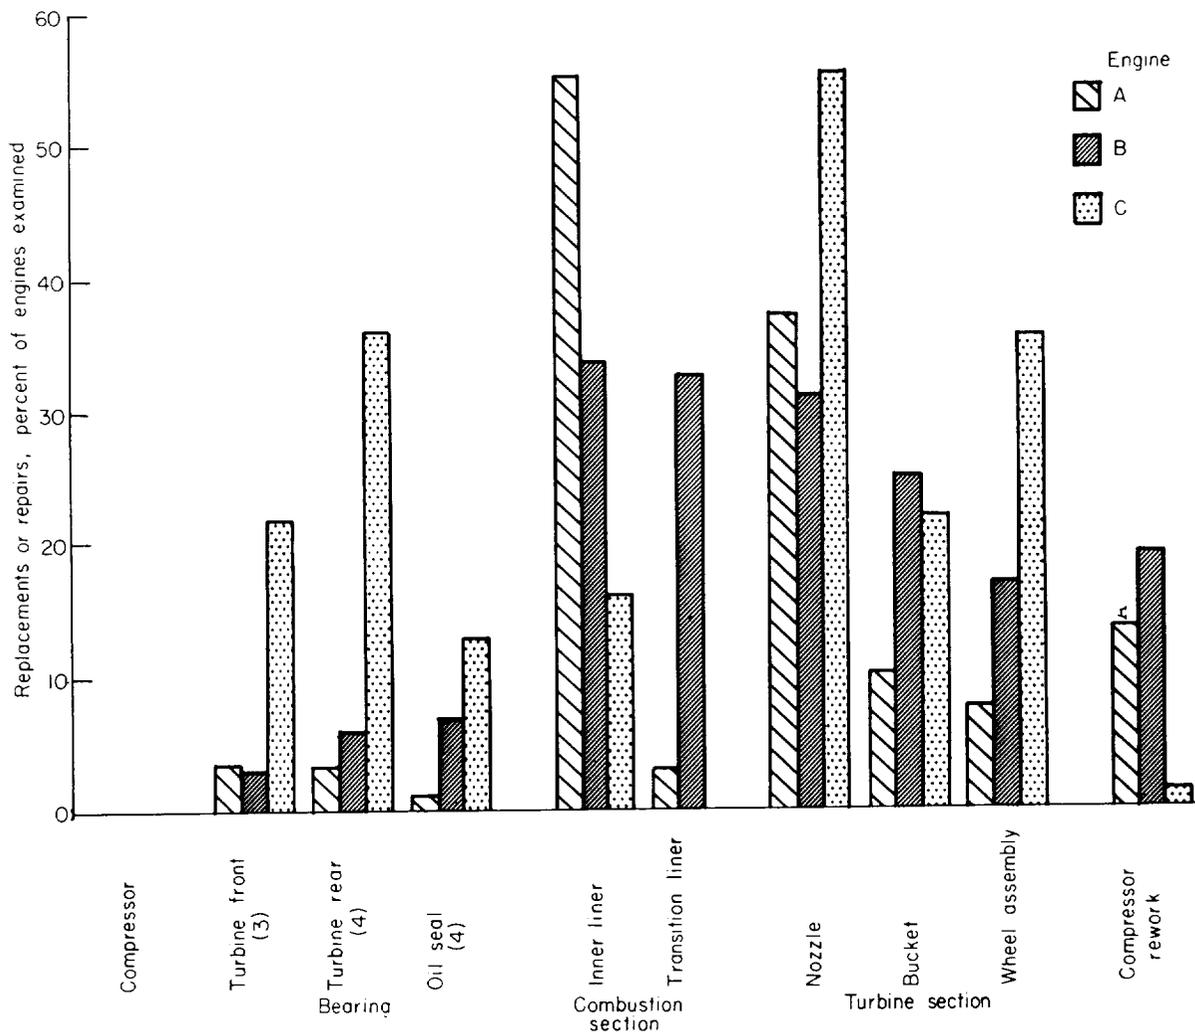
FIGURE 7.—Components replaced or repaired in the field (from Summary of Field Maintenance and Repair).

These data from field repairs show that many hot-section parts are being replaced on engines going through minor repair. For example, 35 percent of the C engines had wheel assemblies replaced (perhaps because of either bucket or disk failures), 25 percent of the B engines had buckets replaced, 55 percent of the C engines had nozzle diaphragms replaced or repaired, and 55 percent of the A engines required replacement of the combustor inner liner. Although bearing replacements were high, it will be pointed out later that, because of the absence of an accurate

criterion of bearing failures, the fact that a bearing is replaced does not necessarily mean that the bearing was bad. Also, it is clear that the life of a component varies with engine design. For example, replacement of a combustor inner liner was required in 55 percent of the A engines but in only 15 percent of the C engines. Data were not available to permit association of these replacements with operating times of the engines.

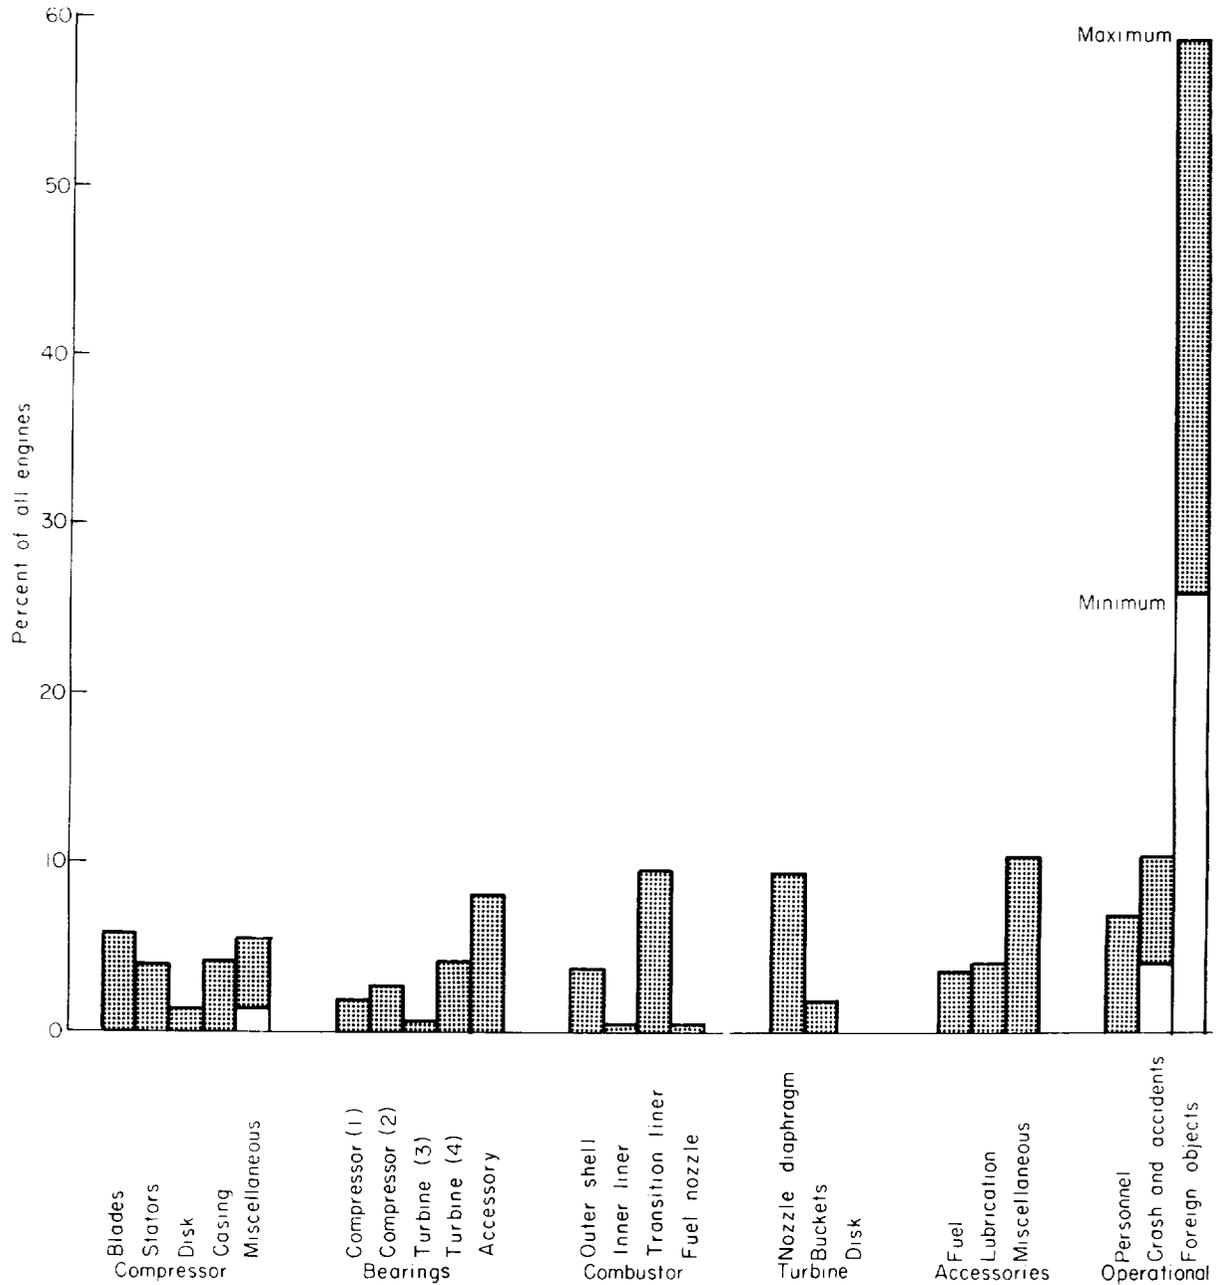
FIGURE 9. Causes for engine overhaul for five engine models (from DIR's).

particular engine part. The causes of overhaul are summarized by section of the engine (e.g., bearings, combustor assembly, etc.) for all five models in figure 9. The most frequent reason for engine overhaul was foreign-object damage (varying between 26 and 59 percent), the minimum being higher than the maximum for any other cause.

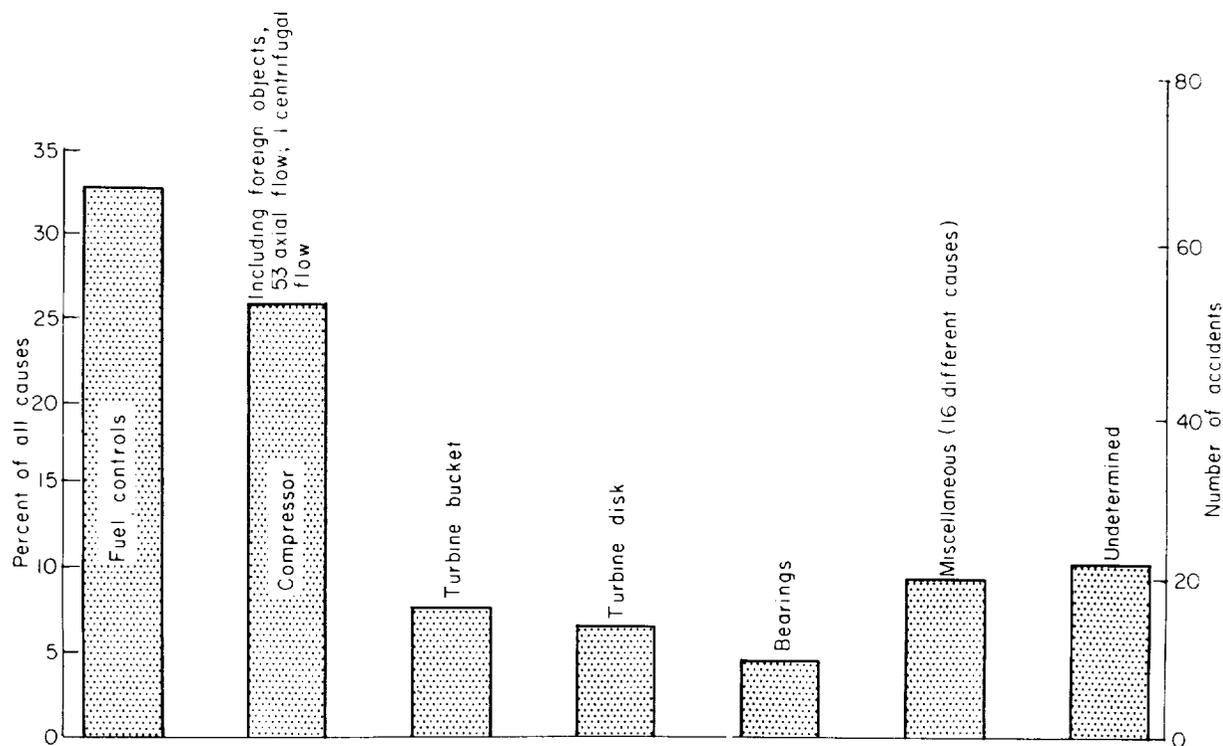
FIGURE 13. Distribution of causes of engine failure or malfunction that resulted in 205 Air Force jet aircraft accidents during 1953 (ref. 4). (Aircraft destroyed in about half the accidents resulting from each cause.)

tion was 7.9 per 100,000 aircraft flying hours (ref. 5). It is of interest that the failure rate for axial-flow engines was almost three times that for centrifugal-flow engines (12.0 and 4.1, respectively, per 100,000 aircraft flying hours). Of the 54 accidents attributed to compressor failure, only one involved a centrifugal compressor, although the aircraft flying time accumulated for each engine type was the same, about 1,100,000 hours.

Of the 205 accidents listed in figure 13, 188 involved single-engine aircraft and 17 involved multiengine aircraft; however, the multiengine aircraft had much less exposure to failure (i.e., less operating time). The number of major accidents for multiengine aircraft per unit of operating time (axial-flow engines) was about the same as for all aircraft having axial-flow engines (12.2 and 12.1 per 100,000 aircraft hours, respectively). For the single-engine aircraft, 98 of the 188 accidents, or 52 percent, resulted in

destruction of the aircraft; whereas, for multi-engine aircraft only 2 of the 17 accidents, or 18 percent, resulted in destruction of the aircraft.

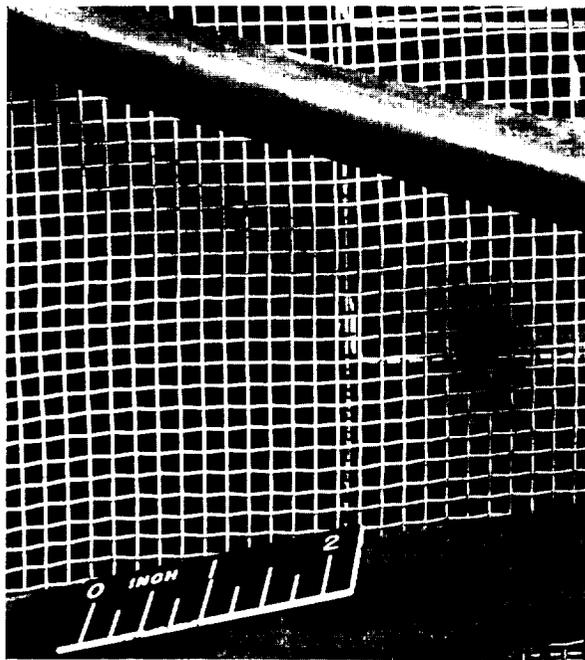
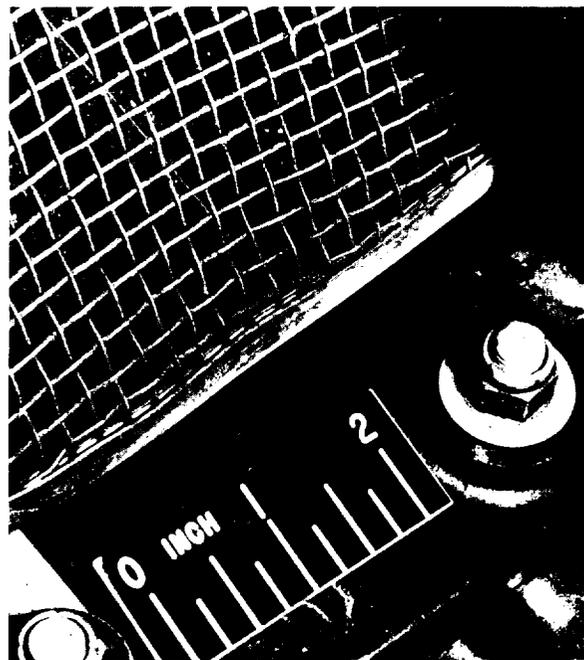
The two screen types were inspected after service on engines in NACA research projects. The fine mesh screens were in excellent mechanical condition after extensive usage; the coarse mesh screens were deteriorated. Broken wires, enlarged mesh dimensions, and large edge clearance between screen and engine frame resulted in openings as large as 0.50 inch in the coarse mesh screen (fig. 3 (b)) through which objects might pass. Thirty-six percent of the engines with the fine mesh screen were damaged, while

(a) Openings 0.132 inch square.

(b) Openings 0.216 inch square.

FIGURE 3. Fixed air-inlet screens on centrifugal engines.

84 percent of the engines with the coarse mesh were damaged, which indicated the need for small screen openings and the importance of construction details that ensure reliability in screen design.

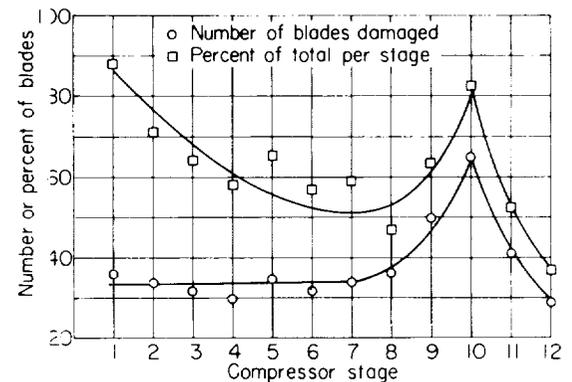
Because the number of blades per stage increases toward the rear of the compressor, the first stage had the highest percentage of damage. The peaks in the curves indicate that the foreign object lingered slightly in the tenth stage. The values do not include stator blades, which are not nearly as critical because of the absence of centrifugal loads.

FIGURE 8.—Number of blades damaged by foreign object in typical axial-flow compressor.

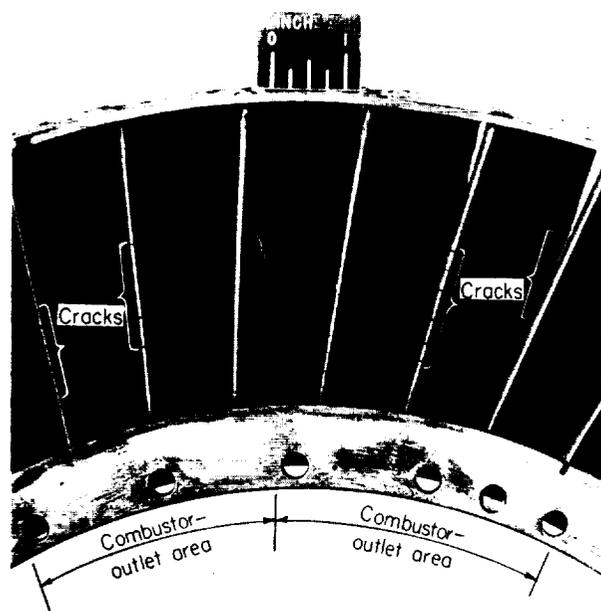
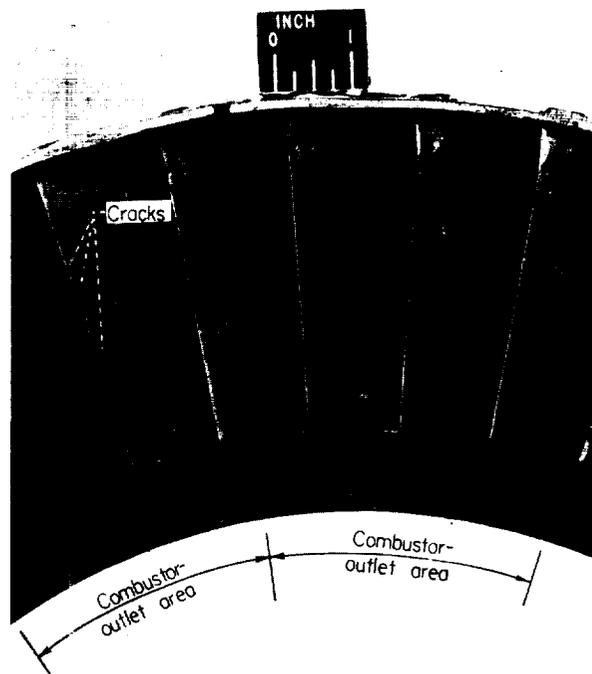
the flame. All these conditions expose the nozzle vanes to repeated cycles of thermal stressing which can cause them to warp, crack, and ultimately fracture. Figure 3 shows the cracks produced at the edges of nozzle vanes by this repeated thermal stressing. The vanes in the middle of the combustor outlets, where the temperature is hottest, show more cracking than the other vanes. Figure 4 shows more detail of the cracks developed by thermal stresses after a number of engine cycles.

FIGURE 3.—Concluded. Nozzle diaphragm showing cracks on edges of vanes (ref. 9).

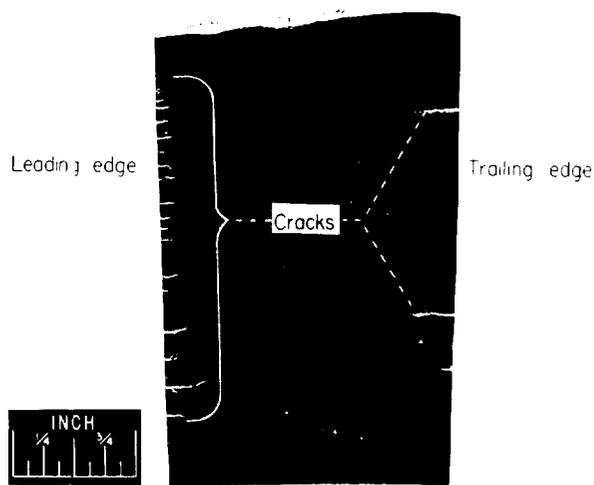
FIGURE 4.—Typical cracks in nozzle-diaphragm vane after 319 cycles (ref. 9).

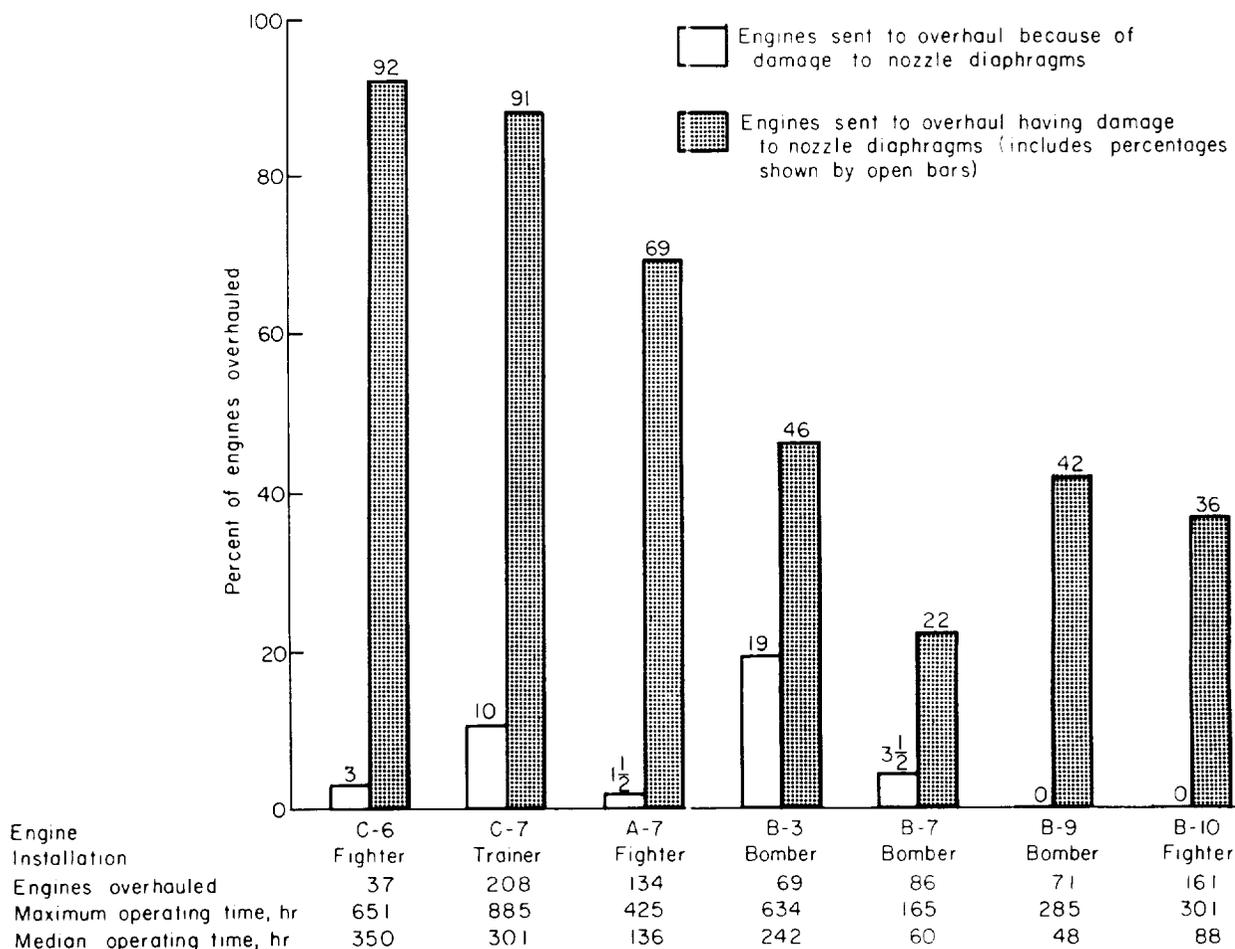
Ordinarily, damaged nozzle diaphragms are repaired or replaced in the field. When base facilities are inadequate, turbojet engines may be sent to overhaul depots for this work. The open bars in figure 5 show the percentages of several types of engine that were sent to overhaul depots because of damaged nozzle diaphragms. For example, of the C-6 engines received at the overhaul depots, 3 percent were sent there because of damage to the nozzle diaphragm. This figure is low for most other engines, but several engines, such as the C-7 and B-3, show much higher percentages of overhauls because of damaged nozzle diaphragms.

Despite the repairs made in the field, a large number of nozzle diaphragms are found damaged during inspection at the overhaul depots in engines sent there for other reasons. This is shown by the cross-hatched bars in figure 5. In the C-6 engines, for example, 92 percent of all the engines sent to overhaul had damaged nozzle diaphragms. (This value includes the 3 percent sent to overhaul because of damaged nozzle diaphragms.)

FIGURE 5.—Damage to nozzle diaphragms reported at overhaul depots. (Data obtained from DIR's, Aug., Sept., Oct., 1953.)

Damage to the nozzle diaphragms does not pose a problem of engine reliability because the damage progresses so slowly that it can be repaired before a failure occurs. The necessary repairs or replacements may be made in the field or during overhauls for other types of damage. As these other types of damage are reduced or eliminated, damage to nozzle diaphragms may become a more important problem to engine reliability.

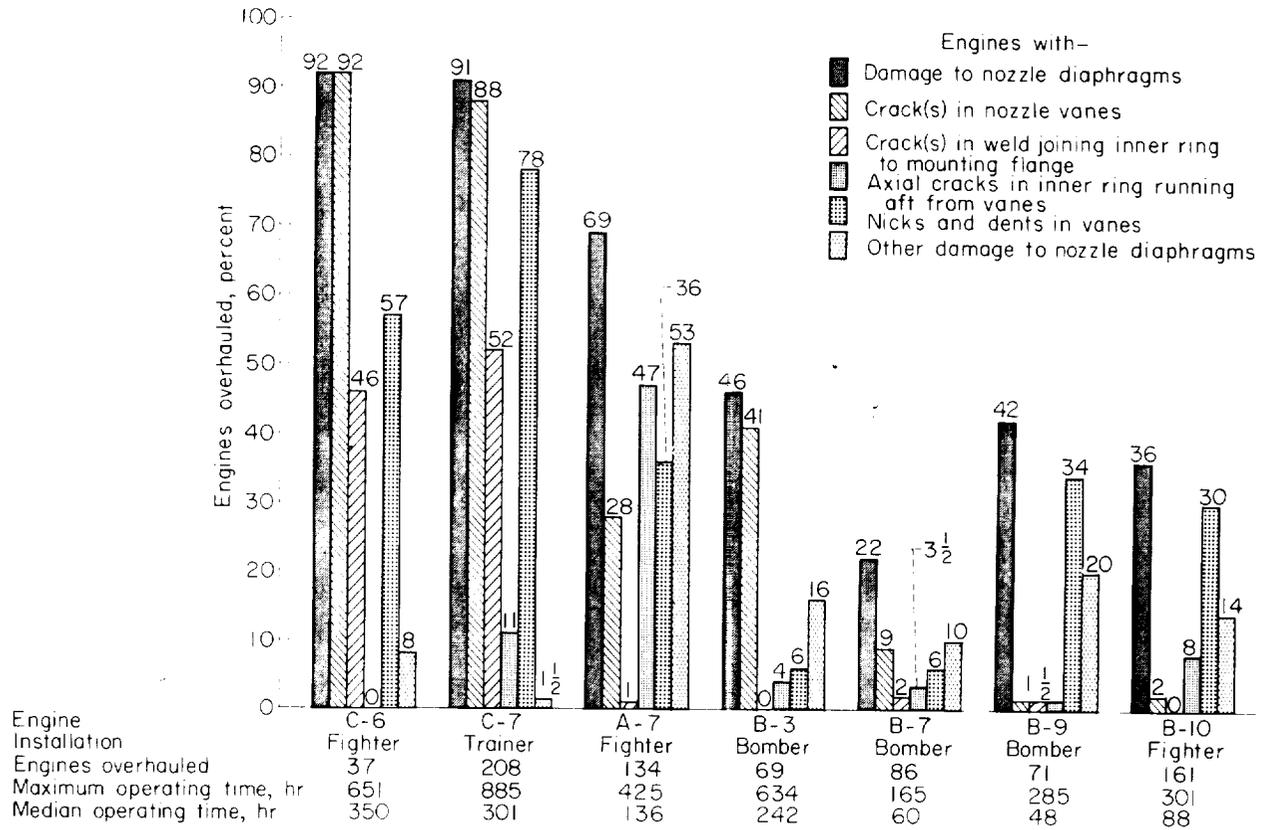
FIGURE 7.— Frequency of occurrence of various types of damage to nozzle diaphragms. (Data obtained from DIR's, Aug., Sept., Oct., 1953.)

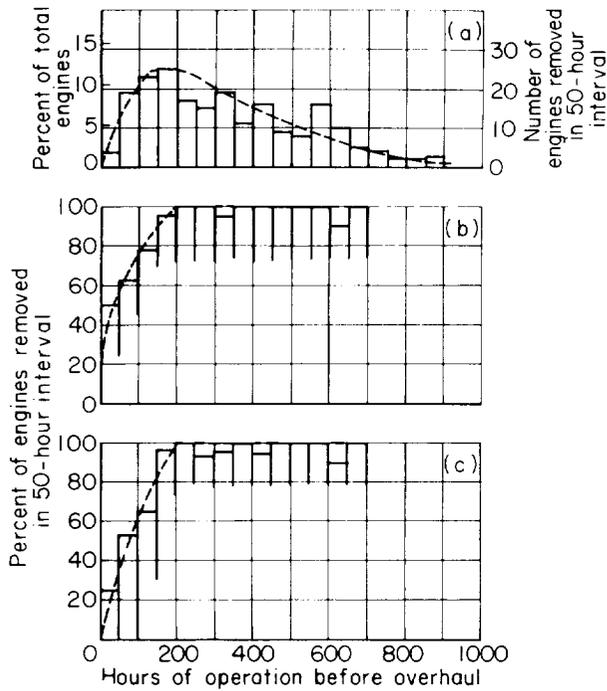
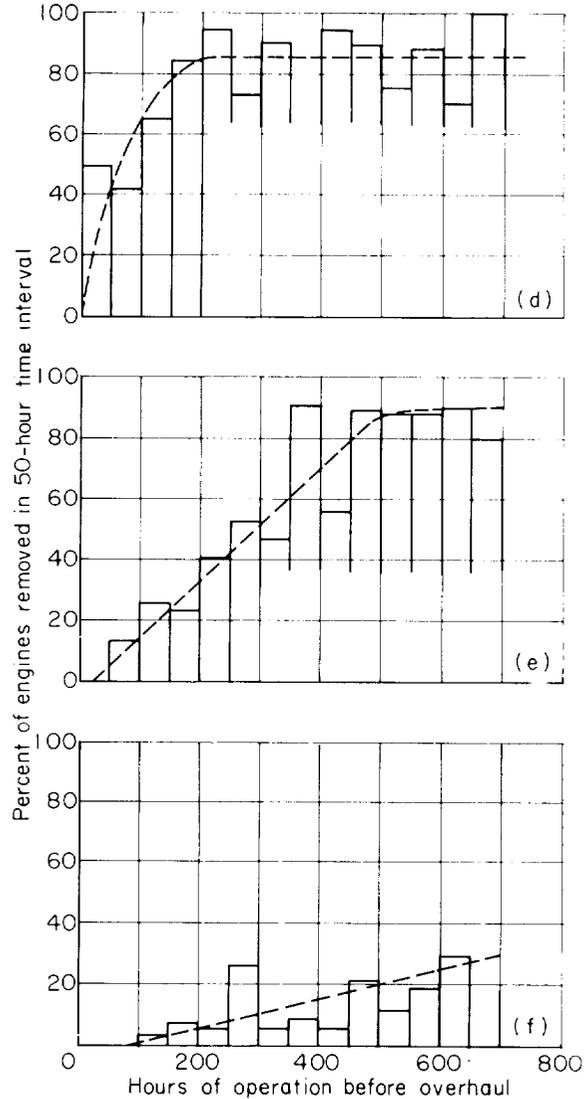
One-half of the engines removed during the first 50 hours of operation had some damage to the nozzle diaphragms (fig. 8(b)). This was true despite the fact that none of these engines were overhauled primarily because of this damage. The number of engines removed with some damage to the nozzle diaphragms increased rapidly with the time of operation, until practically all those removed after 200 hours had some damage to the nozzle diaphragms. A few engines overhauled after 200 hours' operation had no nozzle-diaphragm damage recorded, probably because of field replacements that were not reported in the DIR's. The conclusions that may be drawn from this figure are that practically all nozzle diaphragms will be damaged to some extent after 200 hours of operation, but that this damage will generally not seriously interfere with continued operation of the engine.

As shown in figure 8(c), the edges of the nozzle vanes were cracked in 25 percent of the engines removed during the first 50 hours of oper-

ation. After 200 hours, vanes in practically all the engines were cracked. Cracking was the most frequent type of damage to nozzle diaphragms, being reported in 88 percent of all engines of this type overhauled. The curve roughly parallels that shown in the previous figure for all types of damage.

Cracks running aft of the vane slots developed in the inner ring at a still slower rate. No cracks of this type appeared until the third 50-hour interval of operation, as shown in figure 8(f). The frequency increased continuously to a value of 30 percent after 700 hours of operation.

FIGURE 8.—Overhaul data for 208 C-7 engines. (Data obtained from DIR's Aug., Sept., Oct., 1953.)

FIGURE 8.—Concluded. Overhaul data for 208 C-7 engines. (Data obtained from DIR's Aug., Sept., Oct., 1953.)

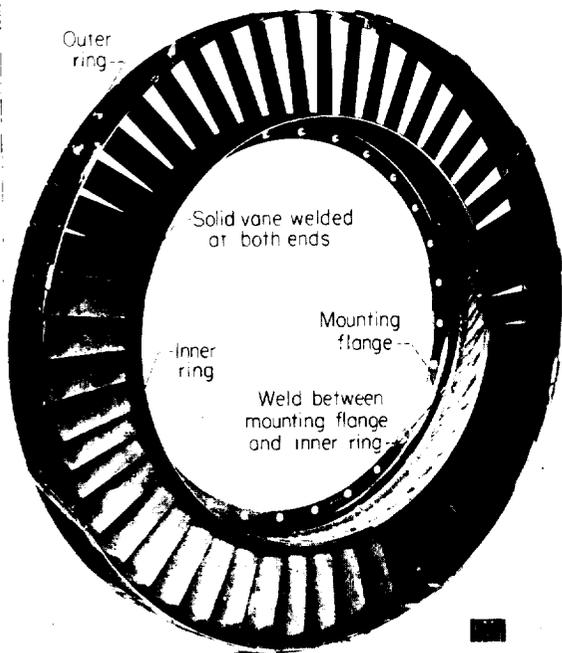
The advantages of the floating design are seen by comparing operating records for different engines. Figure 14(a) shows the design in an early engine. Note that the vanes are welded at both ends to the inner and outer rings and that the mounting flange is welded to the inner ring. Figure 14(b) shows the free-floating design of a later engine. The vanes are alternately welded to either the inner or outer rings, except for a few vanes that are welded at both ends. A bellows between the inner ring and the mounting flange reduces constraints further. The records

(a) From early engine.

show that vane cracking was more frequent in the early design than in the later free-floating design. Part of this difference may have been due to differences in operating conditions and to the use of cooled hollow vanes in the later engine instead of the solid vanes used in the first engine. Cracks in the inner ring running aft from the vane slots were more frequent with the floating design, however. These cracks often extended into the mounting flange. The records did not show whether these cracks were located

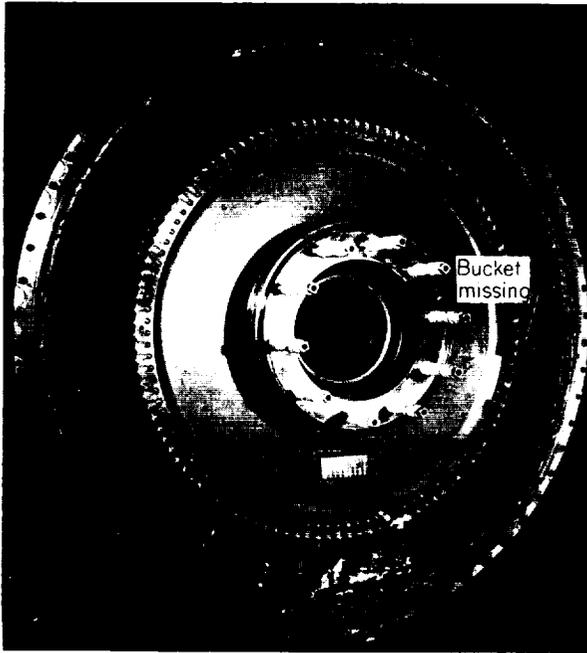
Damage resulting from failure of turbine buckets will likely be much more severe in multistage turbines than it has been for single-stage turbines. In multistage turbines, a fragment from a first-stage bucket failure must pass through subsequent stages where it can cause appreciable damage. A failed three-stage shrouded turbine is shown in figure 2. Failure of a second-stage

(a) Second stage of turbine; all bucket shrouds gone.

FIGURE 2.—Damage to three-stage turbine resulting from failure of second-stage bucket.

bucket broke the tips and shrouds of all the second- and third-stage buckets. The probability is very high that an engine will no longer produce thrust if a bucket fails in any stage except the last; therefore, the reliability must be much

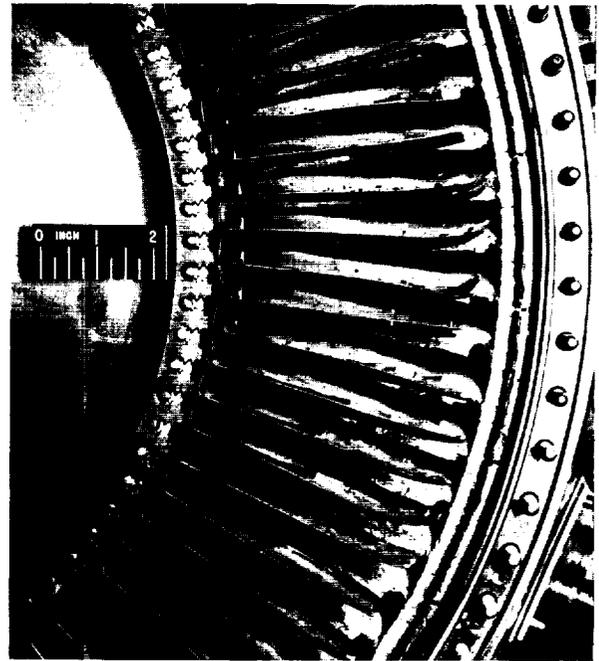
(c) Third stage of turbine; all bucket shrouds gone.

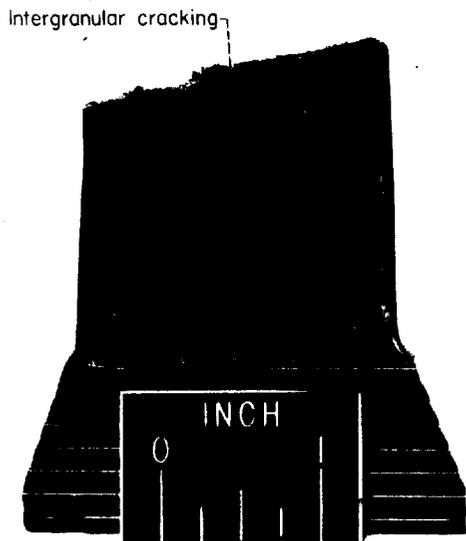
FIGURE 6. Typical stress-rupture fracture.

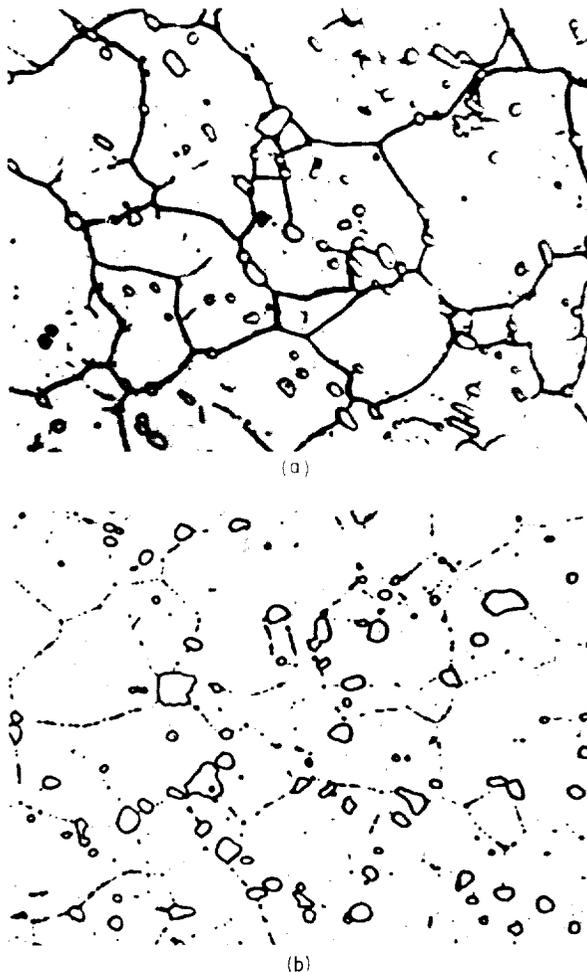
Overtemperature can be so severe as to melt or burn the buckets, or to cause warping, cracking, obvious stretch, or fracture. For some alloys, the occurrence of overtemperature causes changes in the microstructure. This is shown for overtemperated S-816 in figure 25(b), which shows that grain boundary precipitates have been partially redissolved, compared with an undamaged structure in figure 25(a). For some alloys, hardness is changed markedly by re-solution, and such a change may indicate damage.

(b) Severely overtemperated (15 min at 2,000° F) following standard heat treatment.

FIGURE 25.- Effect of overtemperature on microstructure of S-816. X1000.

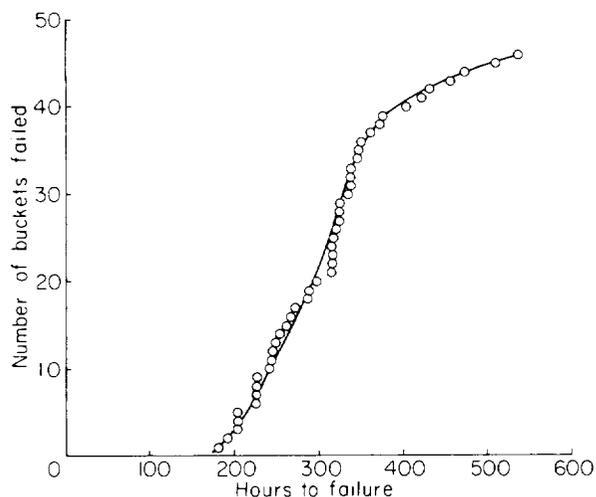
Turbine buckets of a single wheel will differ considerably in time to failure. This is demonstrated in figure 26. A total of 46 turbine buckets of the same material for a given engine, chosen at random from Air Force stock, were installed in a turbine wheel. The engine with this wheel was operated continuously at full engine power until a bucket failure occurred. Operation was continued, with each failed bucket being replaced, until all original buckets had failed. Figure 26 is a plot of number of original buckets failed against time at full engine power. The first failure occurred after 180 hours and the last after 540 hours, a spread ratio of 3:1.

The data of figure 26 also indicate that the failure distribution of these turbine buckets is of the "wear-out" type discussed in chapter II. Thus, after the first bucket had failed, additional failures followed shortly with the rate of failure increasing with time. For buckets of this kind, after the first bucket failure has occurred, additional bucket failures can be expected at very

FIGURE 26.—Typical distribution of turbine-bucket failures. Forty-six buckets in one wheel. (Data from ref. 18.)

short time intervals and the wheel should be equipped with all new buckets.

wheel when the first fails because, as indicated by figure 26, when the first of a sample of buckets fails by stress-rupture, failures of the remainder will follow shortly. It is not desirable to allow even one bucket to fracture by stress-rupture, however, because this results in a high risk of flight accident, particularly since a piece of the bucket of the order of one-half the airfoil has been released. Although this procedure has been used in single-stage turbines, it is not permissible for multistage turbines because of the greatly increased likelihood of a serious accident.

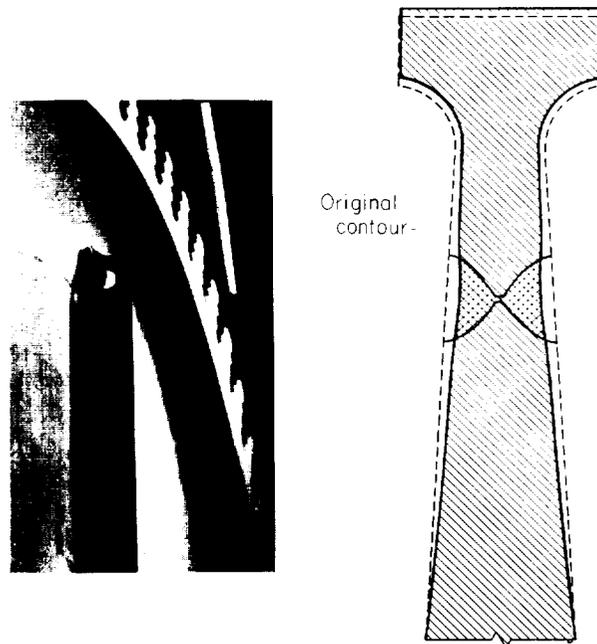
If substantial overtemperature operation is encountered, the web may be subjected to creep that may lead to severe necking with an accompanying increase in the over-all diameter of the disk. This condition is shown in figure 9. A composite disk is shown, although the difficulty could also occur with disks fabricated from a single alloy. The dashed line shows the original contours of the disk and the solid line the contour after necking has taken place. In this case, considerable deformation took place in the weld area. A photograph of a necked disk is also shown in figure 9. The face of the disk was originally a straight-line contour; the light shining through

FIGURE 9.—Growth of welded turbine disk.

between the straight edge and the disk indicates that necking has taken place.

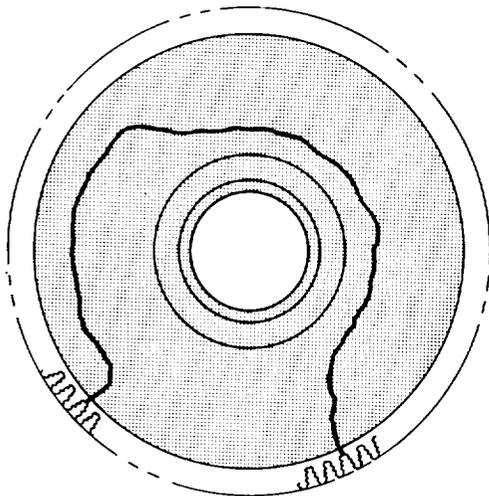
If allowed to proceed, the deformation or necking mechanism can lead to a burst such as that shown in figure 10. The photograph shows a disk fabricated of one material that had been operated in an engine having warped cooling-air baffles. This type of failure can be as catastrophic as a center burst.

FIGURE 10.—Turbine-disk burst as result of excessive growth of web.

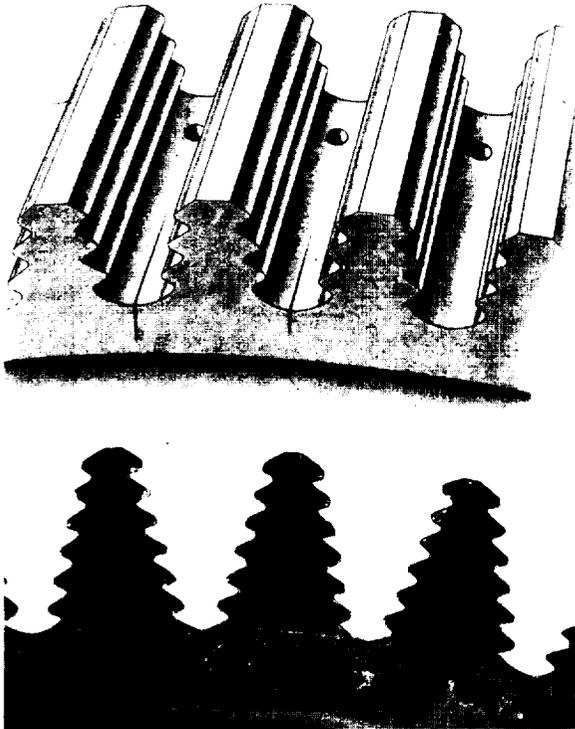
Thermal-fatigue cracks.—As stated previously, the combined effects of centrifugal loading and thermal gradients induce high compressive stresses in the rim area of the turbine disk at rated-speed operation. During starting, the thermal gradients in the disk are even more severe; as a consequence, the stresses are further increased to the point where they frequently exceed the yield strength of the alloy. This induces an immediate compressive plastic flow. In some cases further

FIGURE 12. Thermal-fatigue cracks.

plastic flow can take place (at a much reduced rate) by a creep mechanism. This creep can also occur when the stresses induced by the temperature gradient are insufficient to cause immediate plastic flow. In either case, on engine shutdown the plastic flow that occurred at high temperature will induce a residual tensile stress; this stress may also exceed the yield strength of the material and cause plastic flow in tension. Repetition of this cycle in successive starts and stops eventually consumes the capacity of the alloy to deform and the rim cracks. This mechanism of failure, termed thermal fatigue, is described in

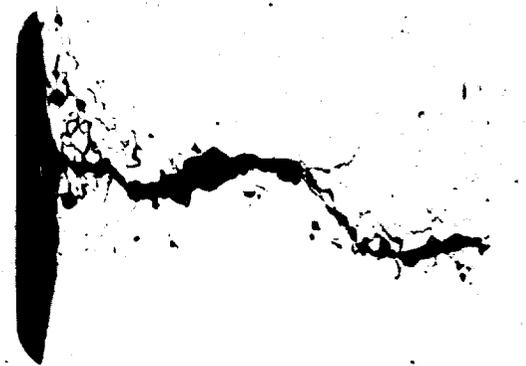
As in the case of the thermal-fatigue cracks, pin-hole cracks can lead to destruction of the turbine disk. The frequency of occurrence of this type of cracking varies with engine type. In one engine model, 76 percent of the disks in engines coming to overhaul (for causes other than disk difficulties) were rejected because of pin-hole cracks. In this engine the cracks seldom occur in only one pin hole. Usually, when they are first detected about five pin holes are found to contain cracks (refs. 10 and 11). The number increases rapidly with additional operating time until most or all of the pin holes contain cracks. Although the average time for the first appearance of the

FIGURE 14.—Intergranular corrosion and crack at pin hole. Unetched; X100; from reference 9.

Of all the sources of failure, the pin-hole crack appears most amenable to elimination. Many of the newer engines have eliminated the pin hole and have substituted "cotter pin" type bucket-retaining devices. This change eliminates not only the stress-concentrating effect of the hole but also the scratching sometimes caused by a sheared pin during bucket removal. In substituting the cotter pin for the retaining pin, the cotter-pin slot machined into the bottom of the serrations should have large fillets. Otherwise, as described in reference 10, cracks may propagate from the sharp corners.

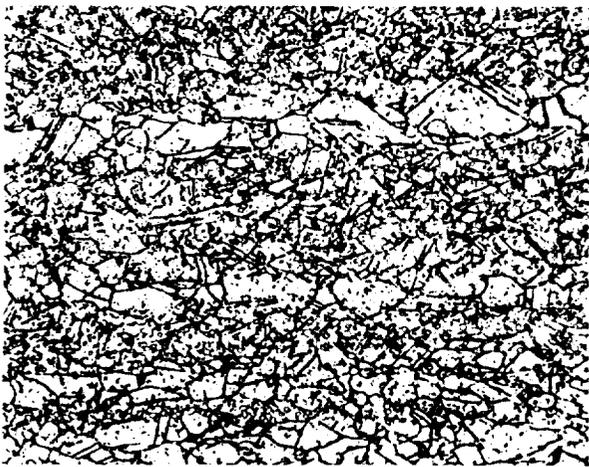
An example of a structural change that reduces life is given for 16-25-6 alloy in figure 16. The heavy precipitate shown was produced by overheating test bars in the laboratory; similar structures have been reported present in turbine disks having serration tensile failures. This change greatly embrittles the alloy.

FIGURE 16. Structure of 16-25-6 alloy after aging. Etchant, aqueous solution of 90 percent hydrochloric acid plus 10 percent nitric acid; X500.

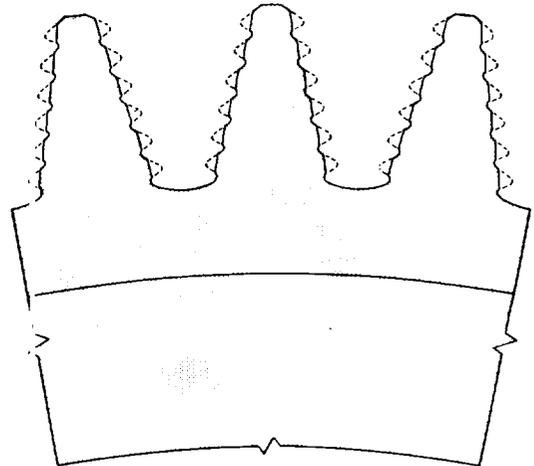
FIGURE 20.—Serration shear failure.

Figure 20 shows a spin-pit disk that has suffered a shear failure.

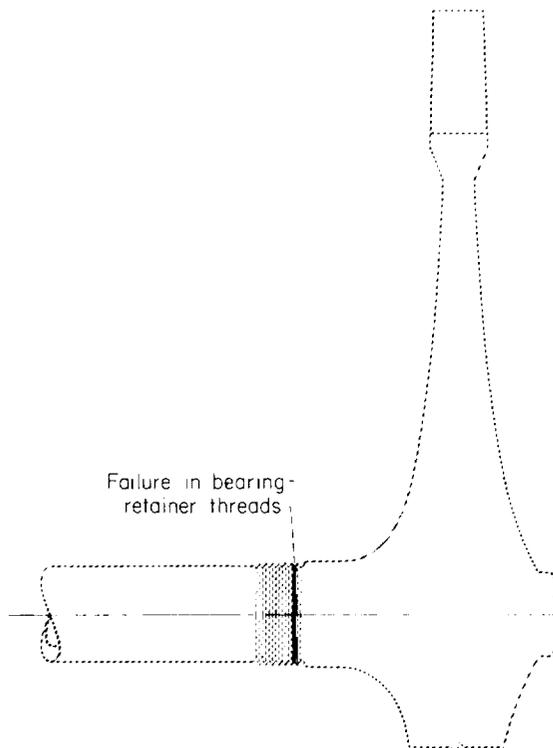
A typical turbine-shaft failure is represented schematically in figure 21. Failure generally occurs at stress-concentration points such as those at the bearing-retainer threads. Since this region of the disk operates at relatively low stress, the failures are attributed to unusual operating con-

FIGURE 21. Turbine shaft failure.

ditions. Several possible causes are (1) torsional vibration of the shaft, (2) overheating of the shaft caused by faulty bearing operation, (3) failure of the cooling-air supply to the bearing, (4) sudden unbalance loads imposed by bucket failures, and (5) gyroscopic loads.

There are no data to indicate whether the failure goes through a detectable incipient stage, but the current practice of inspecting the shaft during overhaul by magnetic means or penetrant oil is undoubtedly sound. Shaft failure, while rare, is extremely destructive.

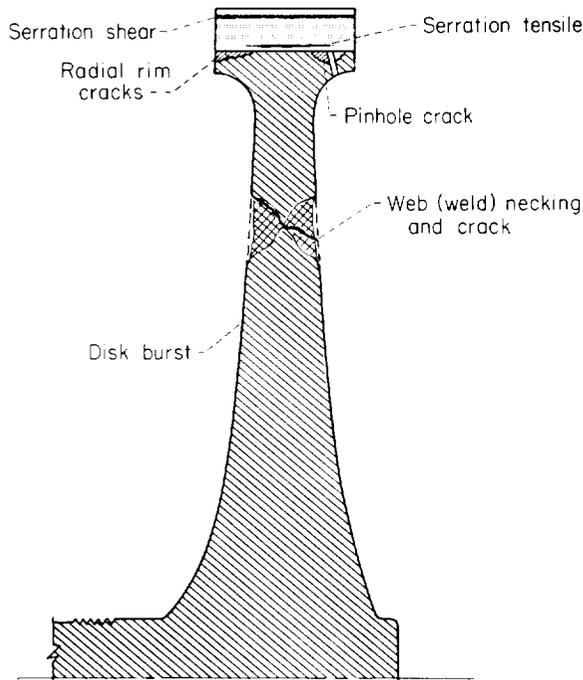
Failure of a turbine disk can cause immediate destruction of an engine. Turbine disks are inspected in manufacture for internal and surface flaws and are usually given overspeed spin tests to check their short-time strength. Difficulties with turbine disks in service can develop through design defects, overheating, thermal cycling, and creep. The principal disk failure mechanisms are summarized in figure 22 and table I.

FIGURE 22.—Locations of disk failures.

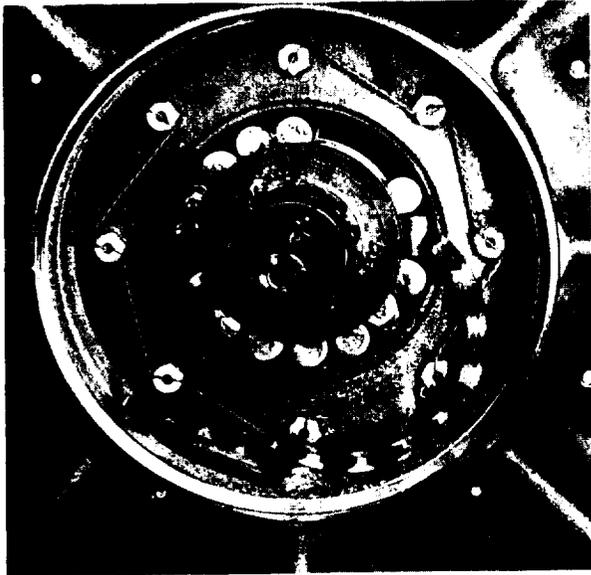
FIGURE 5.—Bearing failure resulting from oil interruption. Engine with jet lubrication of bearings. Photograph shows cage has failed completely. Failure occurred 17 minutes after oil interruption (from ref. 1, appendix B). Other photographs of this engine in figures 6 and 7.
